Stabilizacija betonskega vozišča strateško pomembne ceste z injektiranjem raztezne geopolimerne smole. Primer iz Velike Britanije

Astrid CORBATTO, mag. inž. geoteh nol.

Alberto PASQUETTO, mag. inž. grad.

Urettek d.o.o.

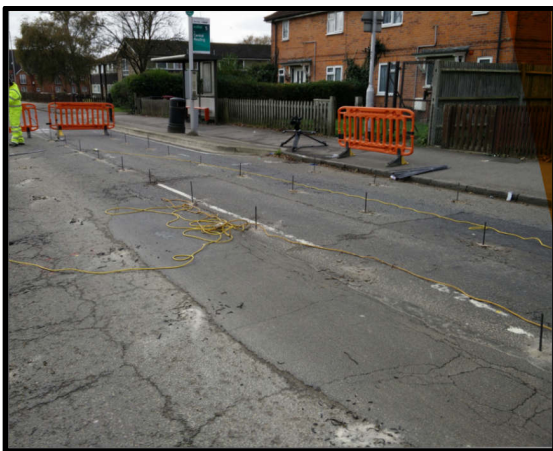
Figure 1: Northumberland Avenue - Reading, UK; location of the treatment and of the Ground Penetrating Radar Survey.

Firstly, in order to fully understand the extent of the issue a GPR survey was completed to analyse the composition of the ground. The results highlighted significant voiding and a soft base layer, meaning throughout a 400 metre stretch of road the integrity of the concrete slabs was being compromised by weak ground. The weakened ground had to be stabilised or a resurface would suffer similar accelerated deterioration; as the ground moves the concrete base also moves

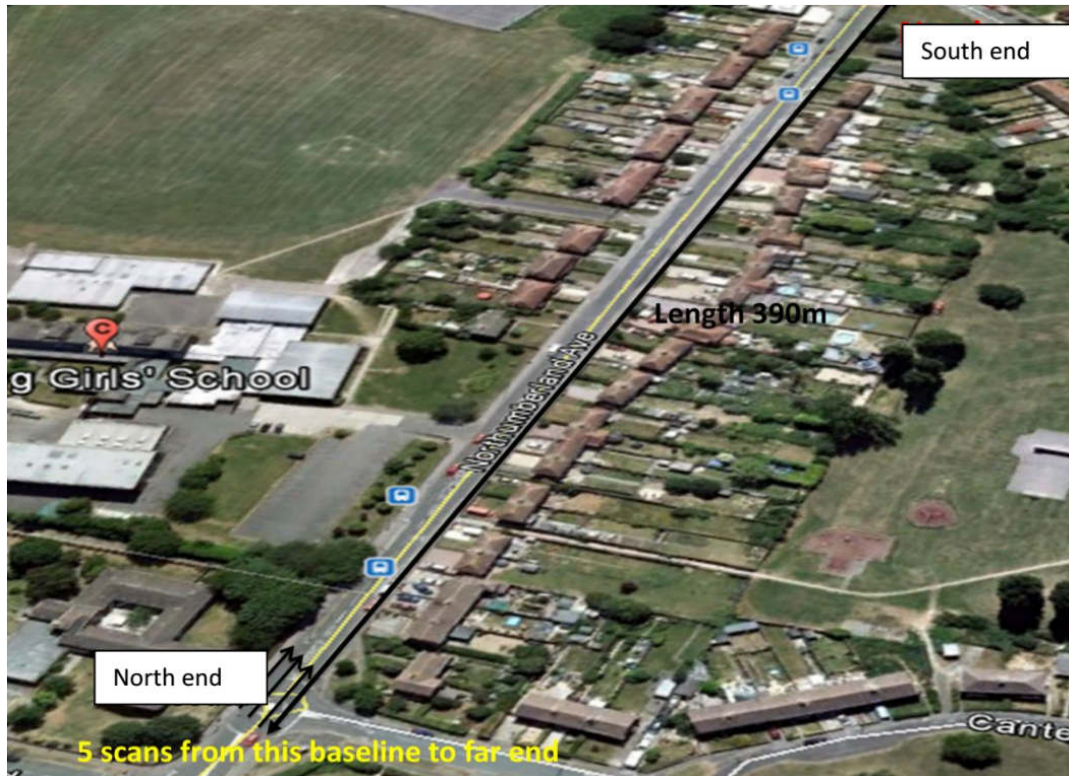
Figure 2: Survey base line on the North side of the Canterbury road junction: the end line is the junction of Northumberland Ave and the junction of Long Barn Lane. This section of Northumberland Avenue is carries a cross section of traffic from regular bus services to delivery vehicles, cars and some HGV movements (Radar Team, 2014).

A Ground Radar survey was commissioned. To seek to determine anomalies that may be detrimental to road stability. The GPR survey was to be conducted to determine the location of anomalies that may prove detrimental to the long term stability of the road. The GPR survey base line was established at the North side of the Canterbury Road Junction with Northumberland Avenue and five scan lines were carried out at approximately 1m separation along Northumberland Avenue to the Long Barn

Lane junction. All data scans terminate at the South end of this section of Northumberland Avenue. Cross scan lines were carried out at intervals along the Avenue to verify probable utilities etc., running along the avenue. The long scan

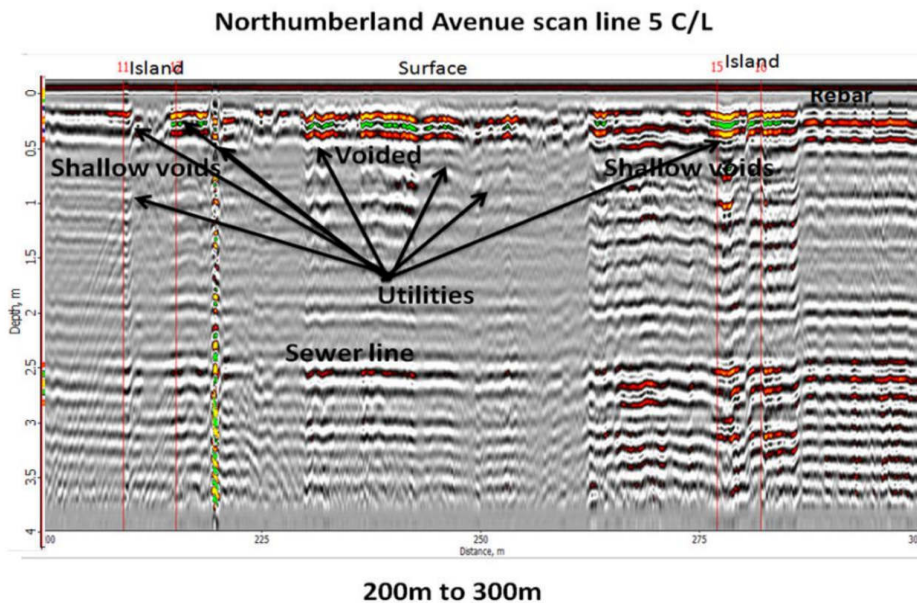
The conductivity figure has been amended to give the correct depth of sewer. These data extracts are from a 390 m scan along the road C/L with data interpretation annotated. In the figure 3 is shown the data related to the area from 200 to 300 m.

Figure 3: Processed data from Scan line 6 across Northumberland Avenue at the South end (from 200 m to 300 m); x-Distance (m); y-Depth (m) (Radar Team, 2014).

Problems clearly exist below the surface, due to poorly reinstated and leaking utility trenches, sewer laterals and sewer itself. The figure 3 and 4 shows utilities that run along the road. After interpreting the long scan lines and the cross scan lines the data were incorporated into the 3d processing software. The criteria was areas of voiding and ground movement. Areas of voiding varying in size below the road deck slabs were annotated as dark and became lighter as the void size (depth) decreased. Less dark areas are where ground movement is interpreted that could lead to problems down the line. The figure 5 is the start of the building a 3d and this is a plan view of the anomaly patterns. The darker areas are interpreted as requiring urgent remedial work to stabilize the road and prevent further break up. This

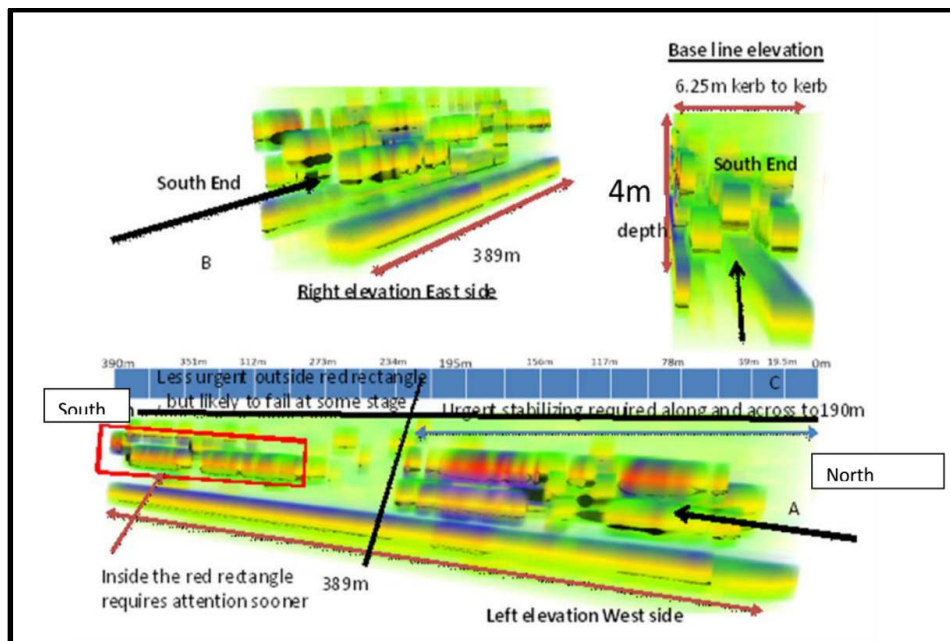
is however only the near surface problems down to around 1m depth. In the figure 6 there is the west elevation which shows the depth and extents of the remedial works required. The three views in figure 8 are from the 3d elevations and show that down to around 4m there are problems.

Figure 8: 3d data analysis of elevations of the 390 m scan along the road C/L - east, west and baseline elevation (Radar Team, 2014).

From the South Base line to 190 m North along the road required urgent action the width of the road. Then from 234 m to 294 m required urgent attention across half of the width. Finally action was required from 314 m to 390 m. The depth of injection should average 3.5 m to ensure

good compaction above and below that point without compromising the sewer. Water leaking from utilities and trenches is exacerbating the stability problems below the slabs. The recommendation was that resin be injected to 2.5m depth and continue during rod extraction.
